# Manhole Inspection Summary

Manhole # S23E1\_013MH

Insp Date: **7/22/08 9:31 AM**

**Location** Address: **2619 Hollins Ferry RD**

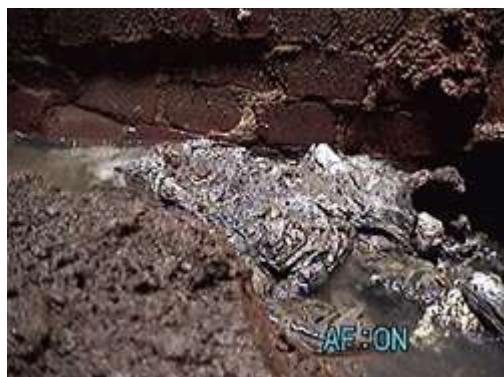
Defect 3

Condition: ☐ Sound ☐ Cracked ☐ Root Intrusion ☐ Deteriorated ☐ Leaks ☒ **Debris**

debris in channel and on bench

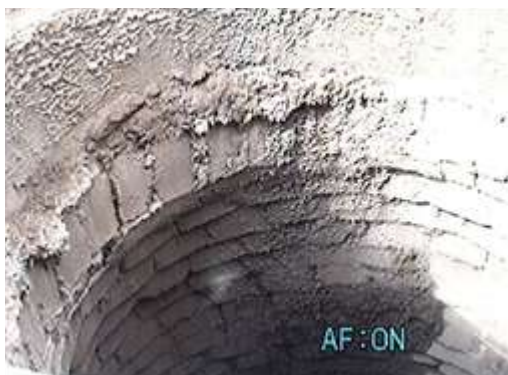
Defect 5

Condition: ☐ Sound ☐ Cracked ☐ Root Intrusion ☐ Loose Brick ☒ **Deteriorated**

Infiltration: ☐ None ☐ Joint ☐ Cracks ☒ **Mortar** ☐ Roots ☒ **Wall**

chimney deteriorated with infiltration from mortar & wall

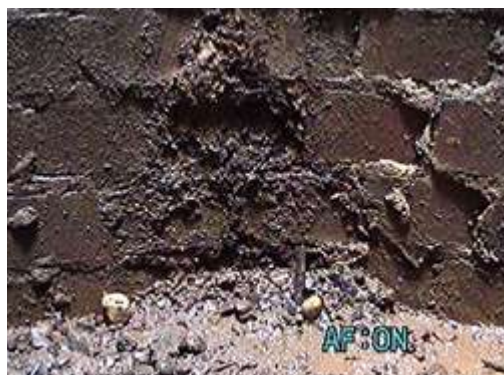
Defect 4

Infiltration: ☐ None ☐ Joint ☐ Cracks ☒ **Mortar** ☐ Roots ☒ **Wall**

barrel infiltration from mortar & wall

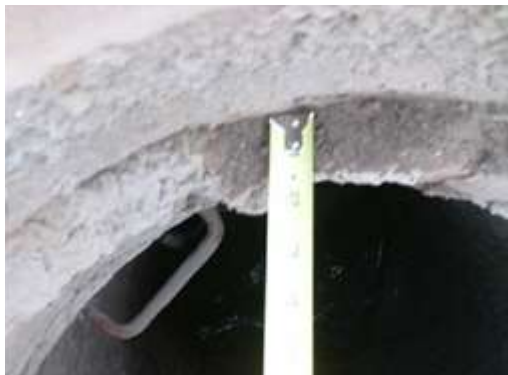
### Defect 2

Offset: **1.5** (in.)

Condition: ☐ Sound ☐ Cracked ☒ **Leaks**

offset

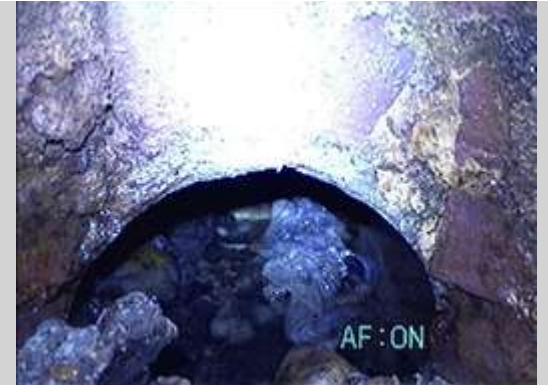
12 O'Clock Outflow

8 in. Circular Gravity Sewer  
Pipe Out @ 12 O'Clock

Pipe Height: **8.4** (in.) Rod and Bar (Angled)  
Pipe Material: **Clay** ☐ Pipe Lined  
Invert Depth: **11.28** (ft.) Flow Characteristics: **Fast**  
Deposits: ☐ None ☐ Mud ☐ Sludge ☒ **Debris** ☐ Grease  
Silt Depth: **0** (in.) Deposits Extent: **Medium**  
Infiltration: **None** Pipe Seal Cond: **Sound**
